Prepared for the Town of Mt. Crested Butte, Colorado

## Condition Assessment of Town Hall & Maintenance Facility

August 17, 2023

Re: Condition Assessment Report  
Town Hall Building & Town Maintenance Facility  
911 & 913 Gothic Road, Mount Crested Butte, Colorado  
Walker Consultants Project No. 23-008747.00

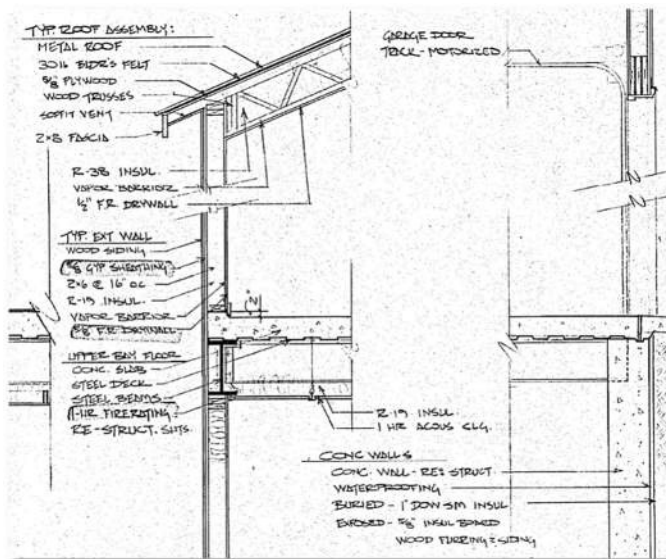
- ❖ Both buildings appear to include a vapor barrier on the warm side of the assembly (behind interior drywall at both walls and soffits of both buildings), which is appropriate for buildings located in very cold climates (Climate Zone 7, per current IECC requirements). This vapor barrier should be maintained (or replaced, as needed) in the event of any interior renovation to prevent vapor drive issues within the wall assembly.
- ❖ Both buildings include wood siding as exterior cladding and metal roofing assemblies with 30-lb. builder’s felt over the Celotex wall and plywood roof sheathing.

**Photo 3:** Wall Section 2 on Sheet A6, from 1982 Drawing Set, for the Town Hall Maintenance Facility.

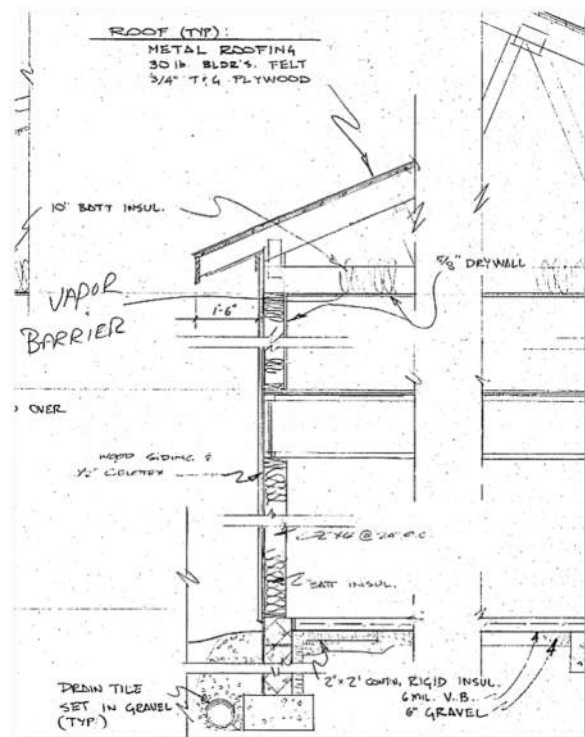
- ❖ The Town Hall Building appears to include ½-inch Celotex as an exterior wall sheathing product, which may potentially indicate that the existing material is asbestos-containing fiberboard sheathing. This material would most likely be impacted and disturbed during any future exterior cladding replacement project, which would warrant asbestos abatement as a part of any such project. Drawings for this building typically show 10-inches of batt insulation at the roof level and 6-inches of batt insulation at exterior walls.
- ❖ The Town Hall Maintenance Facility includes 5/8-inch-thick exterior gypsum sheathing behind the existing wood siding rather than the Celotex indicated for the Town Hall Building. Drawings for this building generally indicate R-38 insulation within the roof assembly and R-19 insulation at the exterior wall assembly.

**Photo 4:** Wall Section 5 on Sheet 5A, from 1978 Drawing Set for the Town Hall Building.

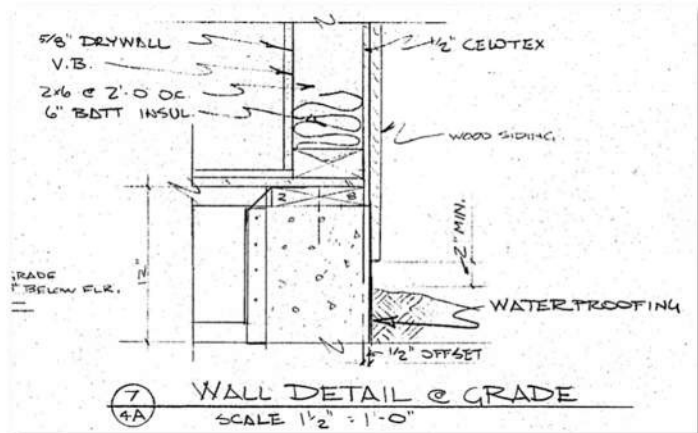
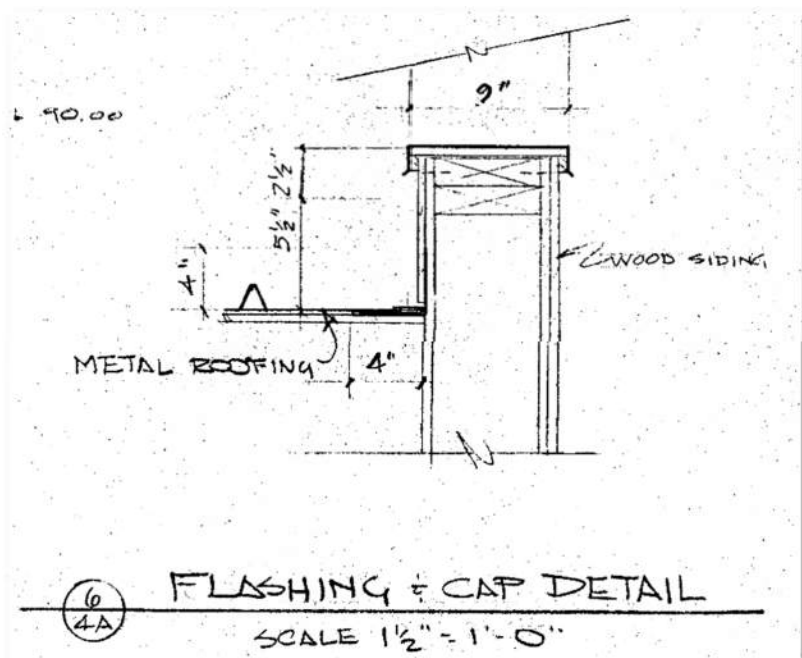
Detail 7 on Sheet 4A (Wall Detail at Grade) for the Town Hall Building (1978 Set) indicates a potential pathway for water and pests to enter the building interior through defects or gaps in deteriorated wood siding at the base of existing exterior walls. Additionally, this detail indicates a generic leader for “waterproofing” to be applied to the exterior of the below-grade wall; however, no material was indicated in the drawings or other details, and this material was not able to be verified at the site.

Detail 6 on Sheet 4A (Flashing & Cap Detail) for the Town Hall Building (1978 Set) indicates a potential location where water infiltration may occur during heavy snow events when snow and ice accumulate or drift across the existing metal roof and may potentially enter at interfaces between vertical wall cladding and metal cap flashings (also known as copings) if the waterproofing layer does not extend under the coping and tie into the wall waterproofing layer. Discontinuities at these locations may lead to leaks and deterioration of structural materials at these transitions.

*Photos 5 & 6: Wall Details 7 (above) and 6 (below), from 1978 Drawing Set for the Town Hall Building.*

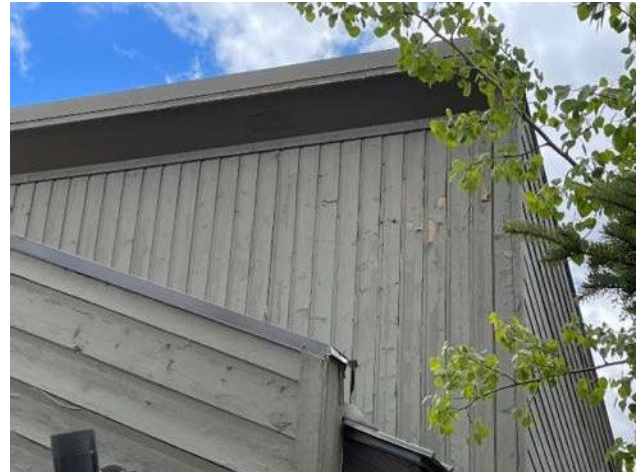
Walker observed widespread evidence of exterior wood siding deterioration, including warping and gaps between siding panels, and extensive deterioration and delamination of exterior paint finishes. However, no active water infiltration was reported during our assessment and only minor, localized water stains were observed within the basement level (break room) and first floor (police department office) levels at “popcorn” ceiling drywall finishes. These stains were reported by management to have been related to previous water infiltration which appeared to have been remediated or had otherwise not worsened and resulted in further damages or displacement of existing drywall.

**Photo 7 (top right):** Typical overview of existing wood siding at Gothic Road (south-facing) elevations, with widespread paint deterioration observed.

Based on the extent of observed cladding assembly deterioration, we recommend that the Town budget for exterior cladding replacement within the next two to three years to protect the existing structures and provide continued office functionality for the Town and its various municipal departments. The Town may wish to consider several types of cladding materials, such as metal panels, insulated metal panels, or fiber cement siding (rather than simply replacement of the wood siding in-kind) to prolong the expected useful life (EUL) of a replacement cladding assembly and finishes.

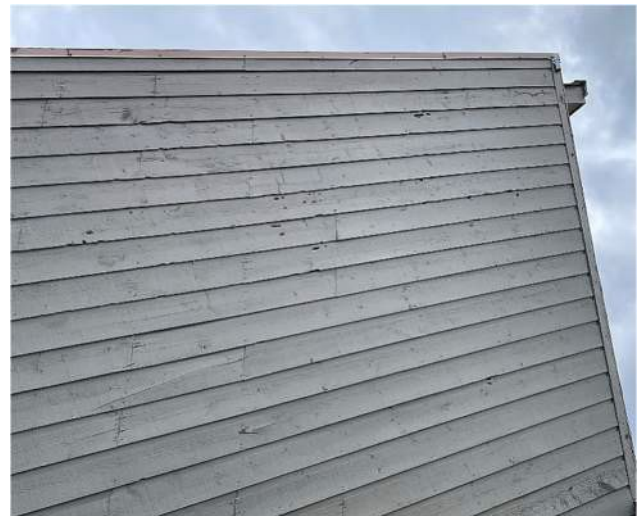
**Photo 9 (bottom right):** Localized gaps and rough edges between wood siding panels (*see arrows*).

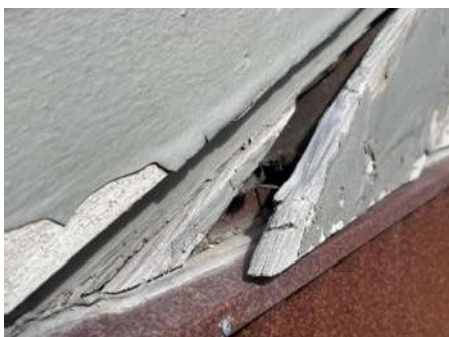
Walker observed several examples of loose, damaged, or displaced wood siding panels, the majority of which were located at cladding transitions (such as at vertical metal flashing interfaces) and at various base wall conditions.

**Photo 10 (below):** Displaced wood siding panel at cladding transition near the Town Hall front entrance, with deteriorated paint finishes and warped wood materials.

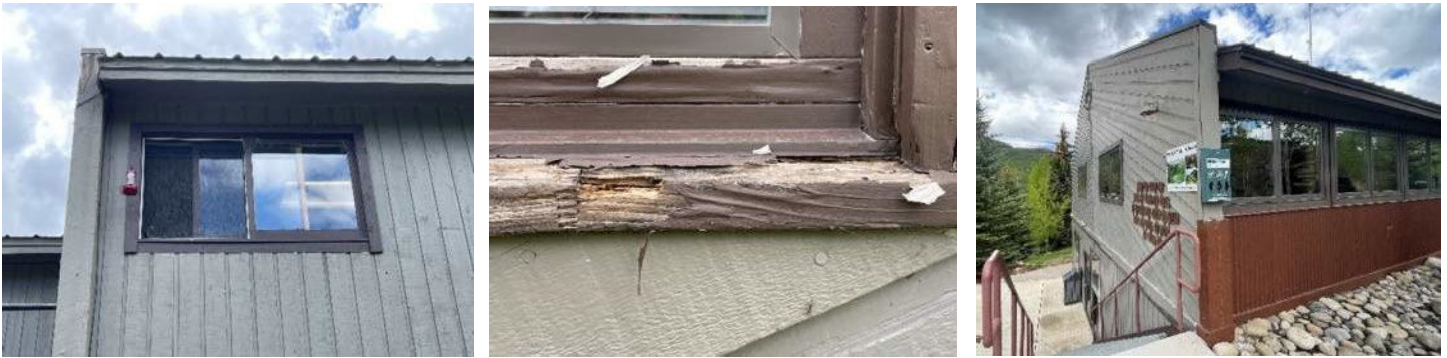
**Photo 11, 12 and 13 (Left to Right):** North-facing Town Hall building elevation with existing wood-framed horizontal slider window (note deteriorated wood siding beneath roof cap flashing); severely deteriorated wood sill plate and paint below window assembly; overview of south-facing building elevation, with metal-framed horizontal slider windows (at right).

Walker recommends that the Town consider replacing the existing window assemblies, either in conjunction with the proposed cladding replacement project, or within the next 5 to 7 years. The existing windows at the Town Building and Maintenance Facility are currently 45 years old, and though no water infiltration is currently reported, the windows will continue to exhibit signs of worsening deterioration and leakage, especially once the flexible window materials (such as internal weatherstrips) within the wood framed IGU assemblies reach the end of their useful lives. Typically, windows begin to experience water infiltration and other localized component failures after approximately 35 or more years in service.

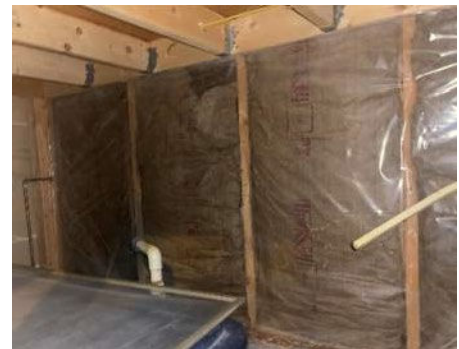
**Photo 14 (above):** Interior view of exterior wall assembly, with R-19 batt insulation, with some darkened/separated facer material.

exterior stud wall assembly was visible, and which also appeared to include some areas of dark stains and separation of the paper facer. Walker did not observe displacement or cracks at existing interior drywall finishes that would typically be indicative of foundation settlement or building lateral movement.

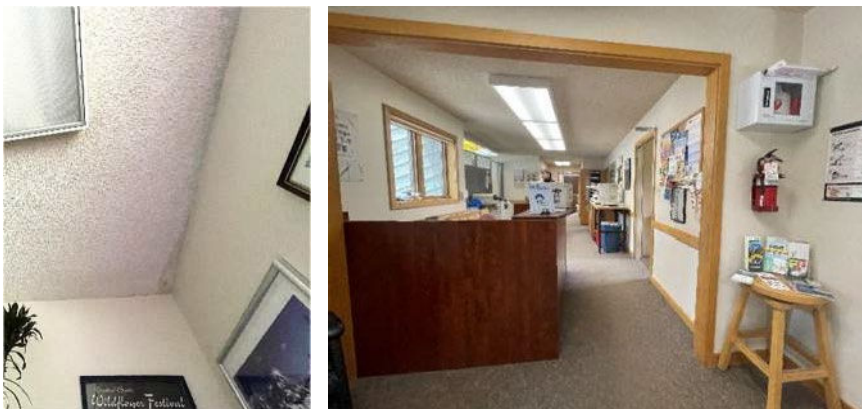
**Photo 15 (far left):** Dark stain at ceiling to wall interface within police department office (below main roof).

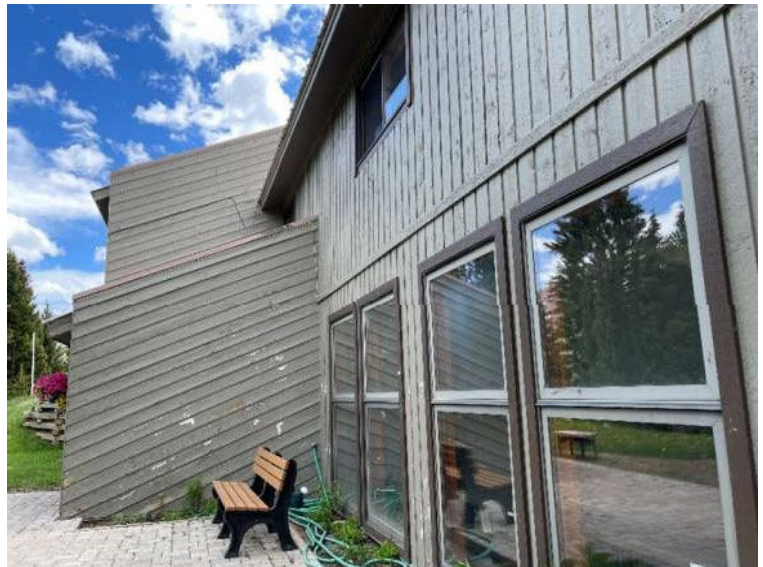
**Photo 18 (above, right):** Overview of north elevation, with re-purposed windows installed at lower level office spaces. Isolated paint distress at wood cladding finishes visible.

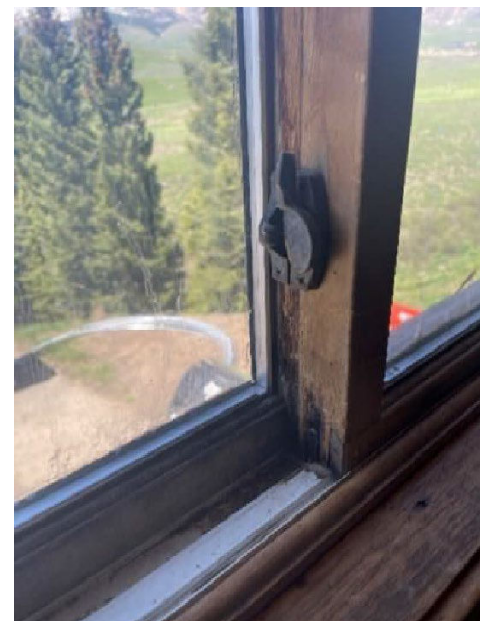
Walker noted that window and door assemblies at the Town Hall Maintenance Facility were generally in good, working condition, although Walker did not attempt to operate all fenestration hardware during our site visit. Windows at the Maintenance Facility were typically wood framed and included both horizontal slider and casement units. No reports of water infiltration at building windows were provided during our on-site assessment. Walker observed one isolated location (within the Town apartment) where the wood frame included dark staining due either to previous moisture infiltration or condensation (or both), although no active water leaks were reported by the tenant.

**Photo 22:** Stain at interior of existing wood window frame, within Town apartment unit.

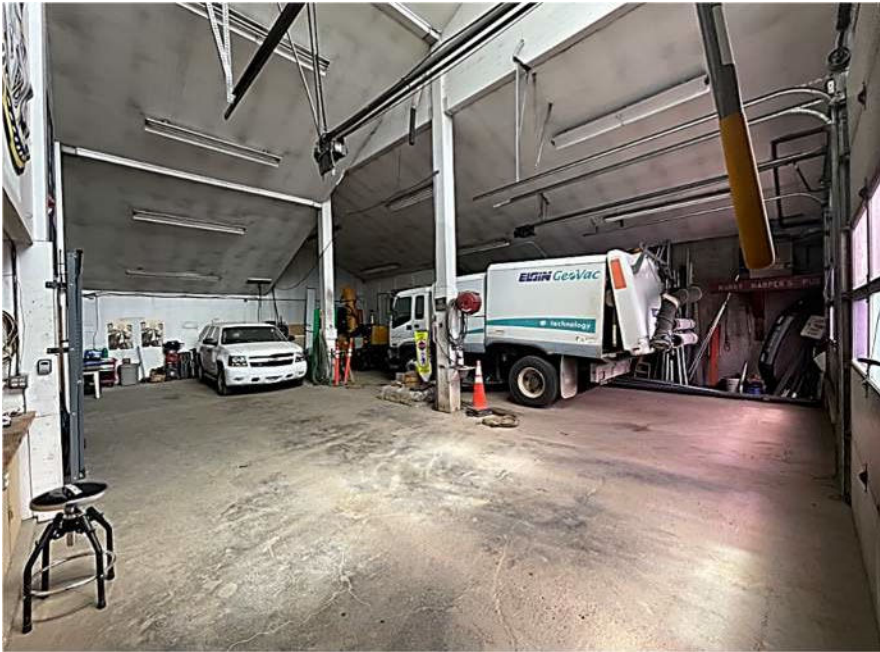
*Photo 28: Overview, including visible slab cracks, at upper garage bay of Town Maintenance Facility.*

Walker observed several isolated cracks and spalls at the upper bay elevated slab.

One condition, the existing cracks and spalls at the elevated composite deck of the upper bay of the Town Maintenance facility, was considered fair. If not addressed or repaired, cracks and spalls within a composite deck assembly can provide direct pathways for moisture and de-icing salts to potentially corrode the structural steel deck and other steel reinforcement and structural framing. If the upper bay remains in use as a garage (including frequent access by vehicles during the winter months), Walker recommends consideration of concrete slab repairs (i.e. crack rout and seal and concrete patching), as well as application of a heavy-duty traffic-bearing membrane to protect this elevated structure from continued damage or deterioration.

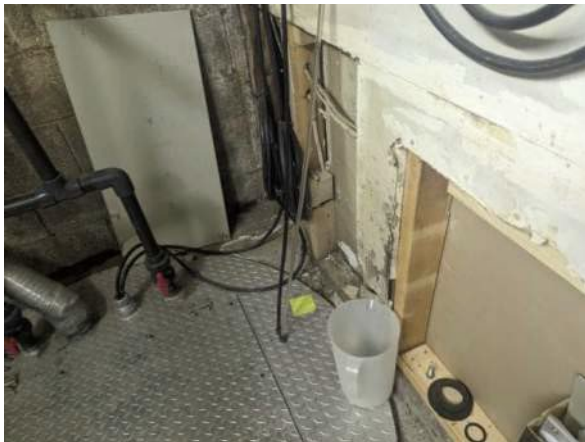
**Photo #11** Small amounts of visible mold  
growth on drywall paper in the  
mechanical room of Town Hall  
Building

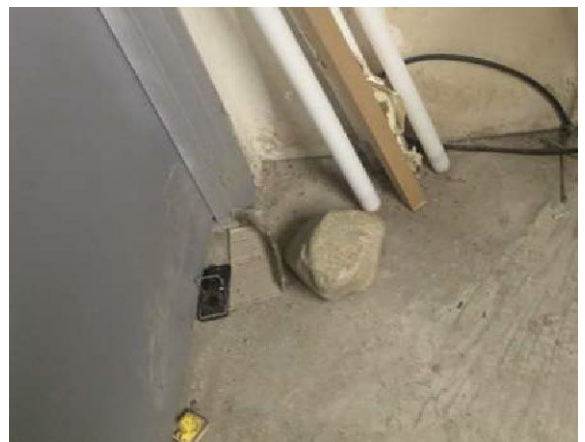
**Photo #12** Rodent feces and mouse traps in  
mechanical room of Town Hall  
Building

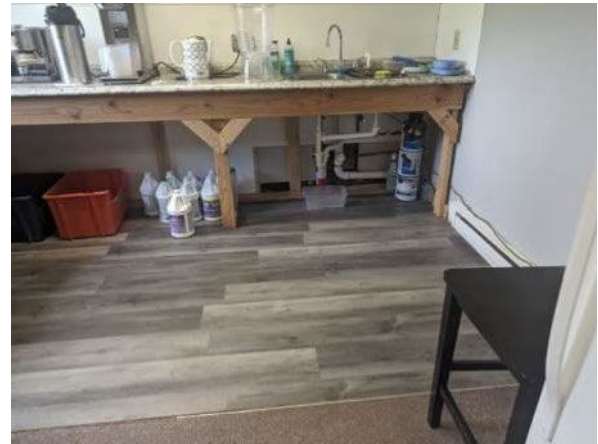
**Photo #14** Breakroom wall that was remediated for mold following a roof/water infiltration event

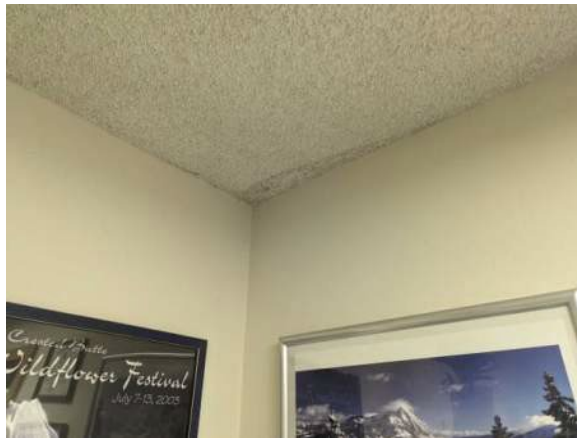
**Photo #15** Evidence of prior roof leak in one of the offices in Town Hall Building

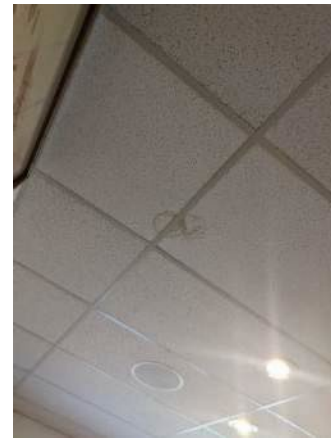
**Photo #16** Evidence of prior roof leak in the town council chambers, Town Hall Building

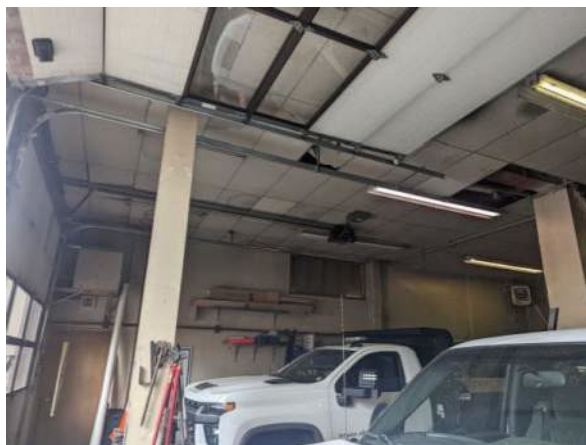
**Photo #17** Evidence of previous water leaks in the lower Maintenance Building garage

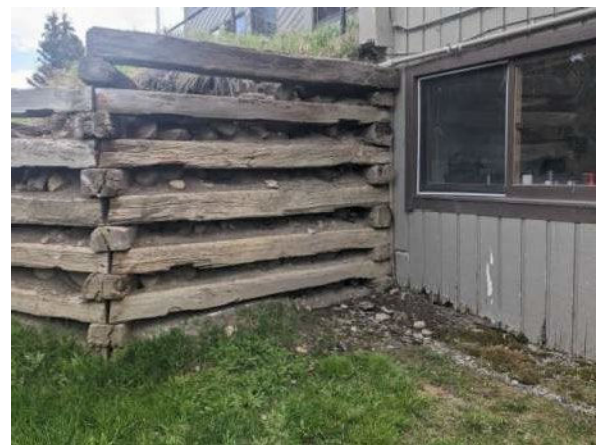
**Photo #18** Gaps greater than 1/4 inch along the bottom of the wall – Town Hall Building

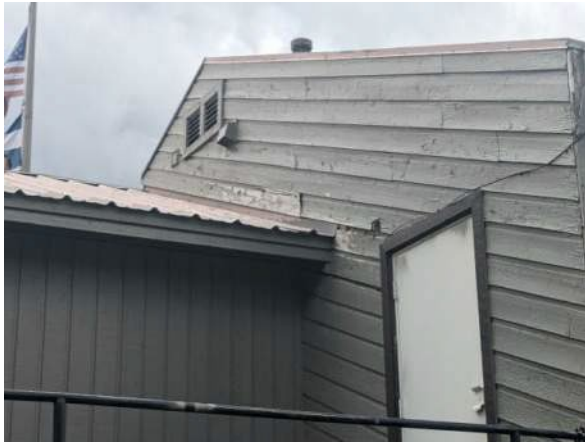
**Photo #19** Vents with greater than  $\frac{1}{4}$  gaps on Town Hall Building

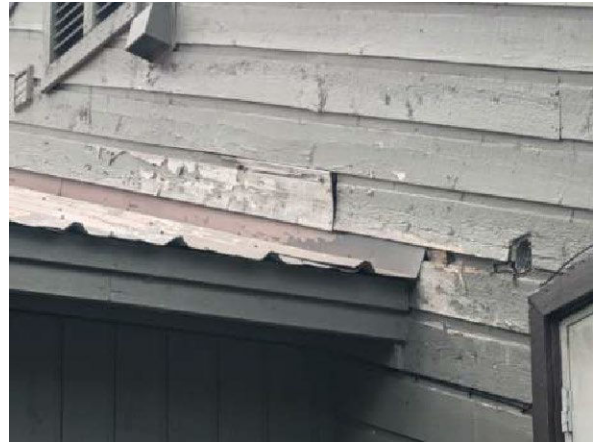
**Photo #20** Gaps in cladding that exceed  $\frac{1}{4}$  inch, Town Hall building

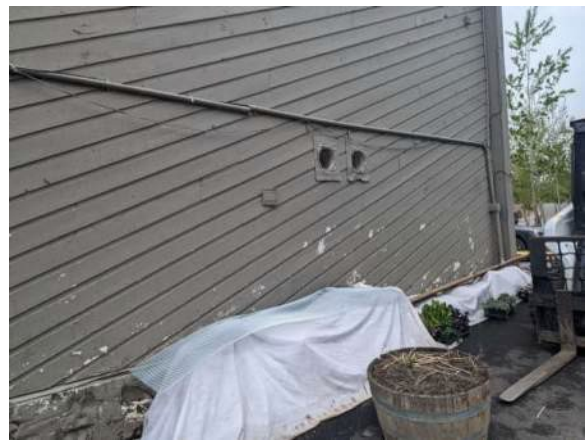
**Photo #21** Uncovered vents on North elevation of Maintenance Building – also cover for rodents up against

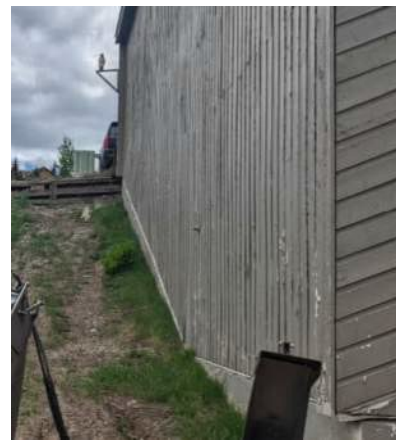
**Photo #22** Gaps in cladding on east elevation of Maintenance Building

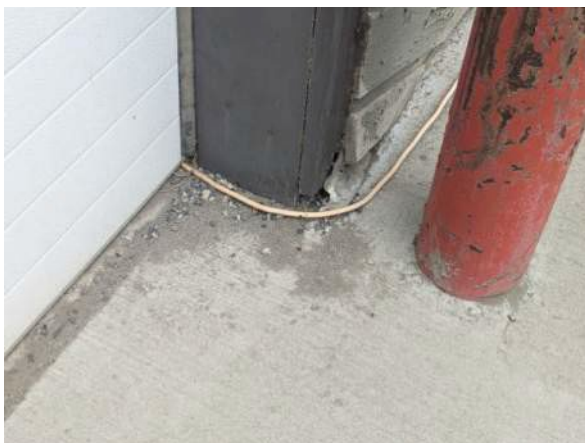
**Photo #23** Gaps on South elevation of Maintenance building greater than  $\frac{1}{4}$  inch

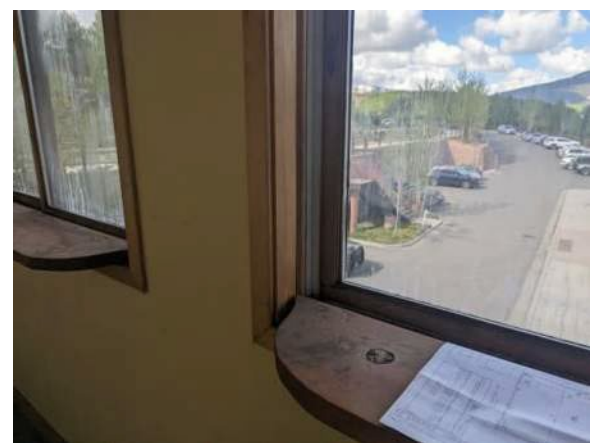
**Photo #24** Evidence of condensation on windows on top floor of Maintenance Building
