TOWN OF RIDGWAY  
BEAVER CREEK INFILTRATION GALLERY  
ADDENDUM NO. 2  
April 24, 2026

REPLACE : REPLACE the attached sheets G2, C-1, C-2, C-4, C-8, ER-1, and ER-2 for the those sheets included in the original copies of those sheets.

BEAVER CREEK  
DIVERSION  
RESTORATION  
INFILTRATION  
GALLERY

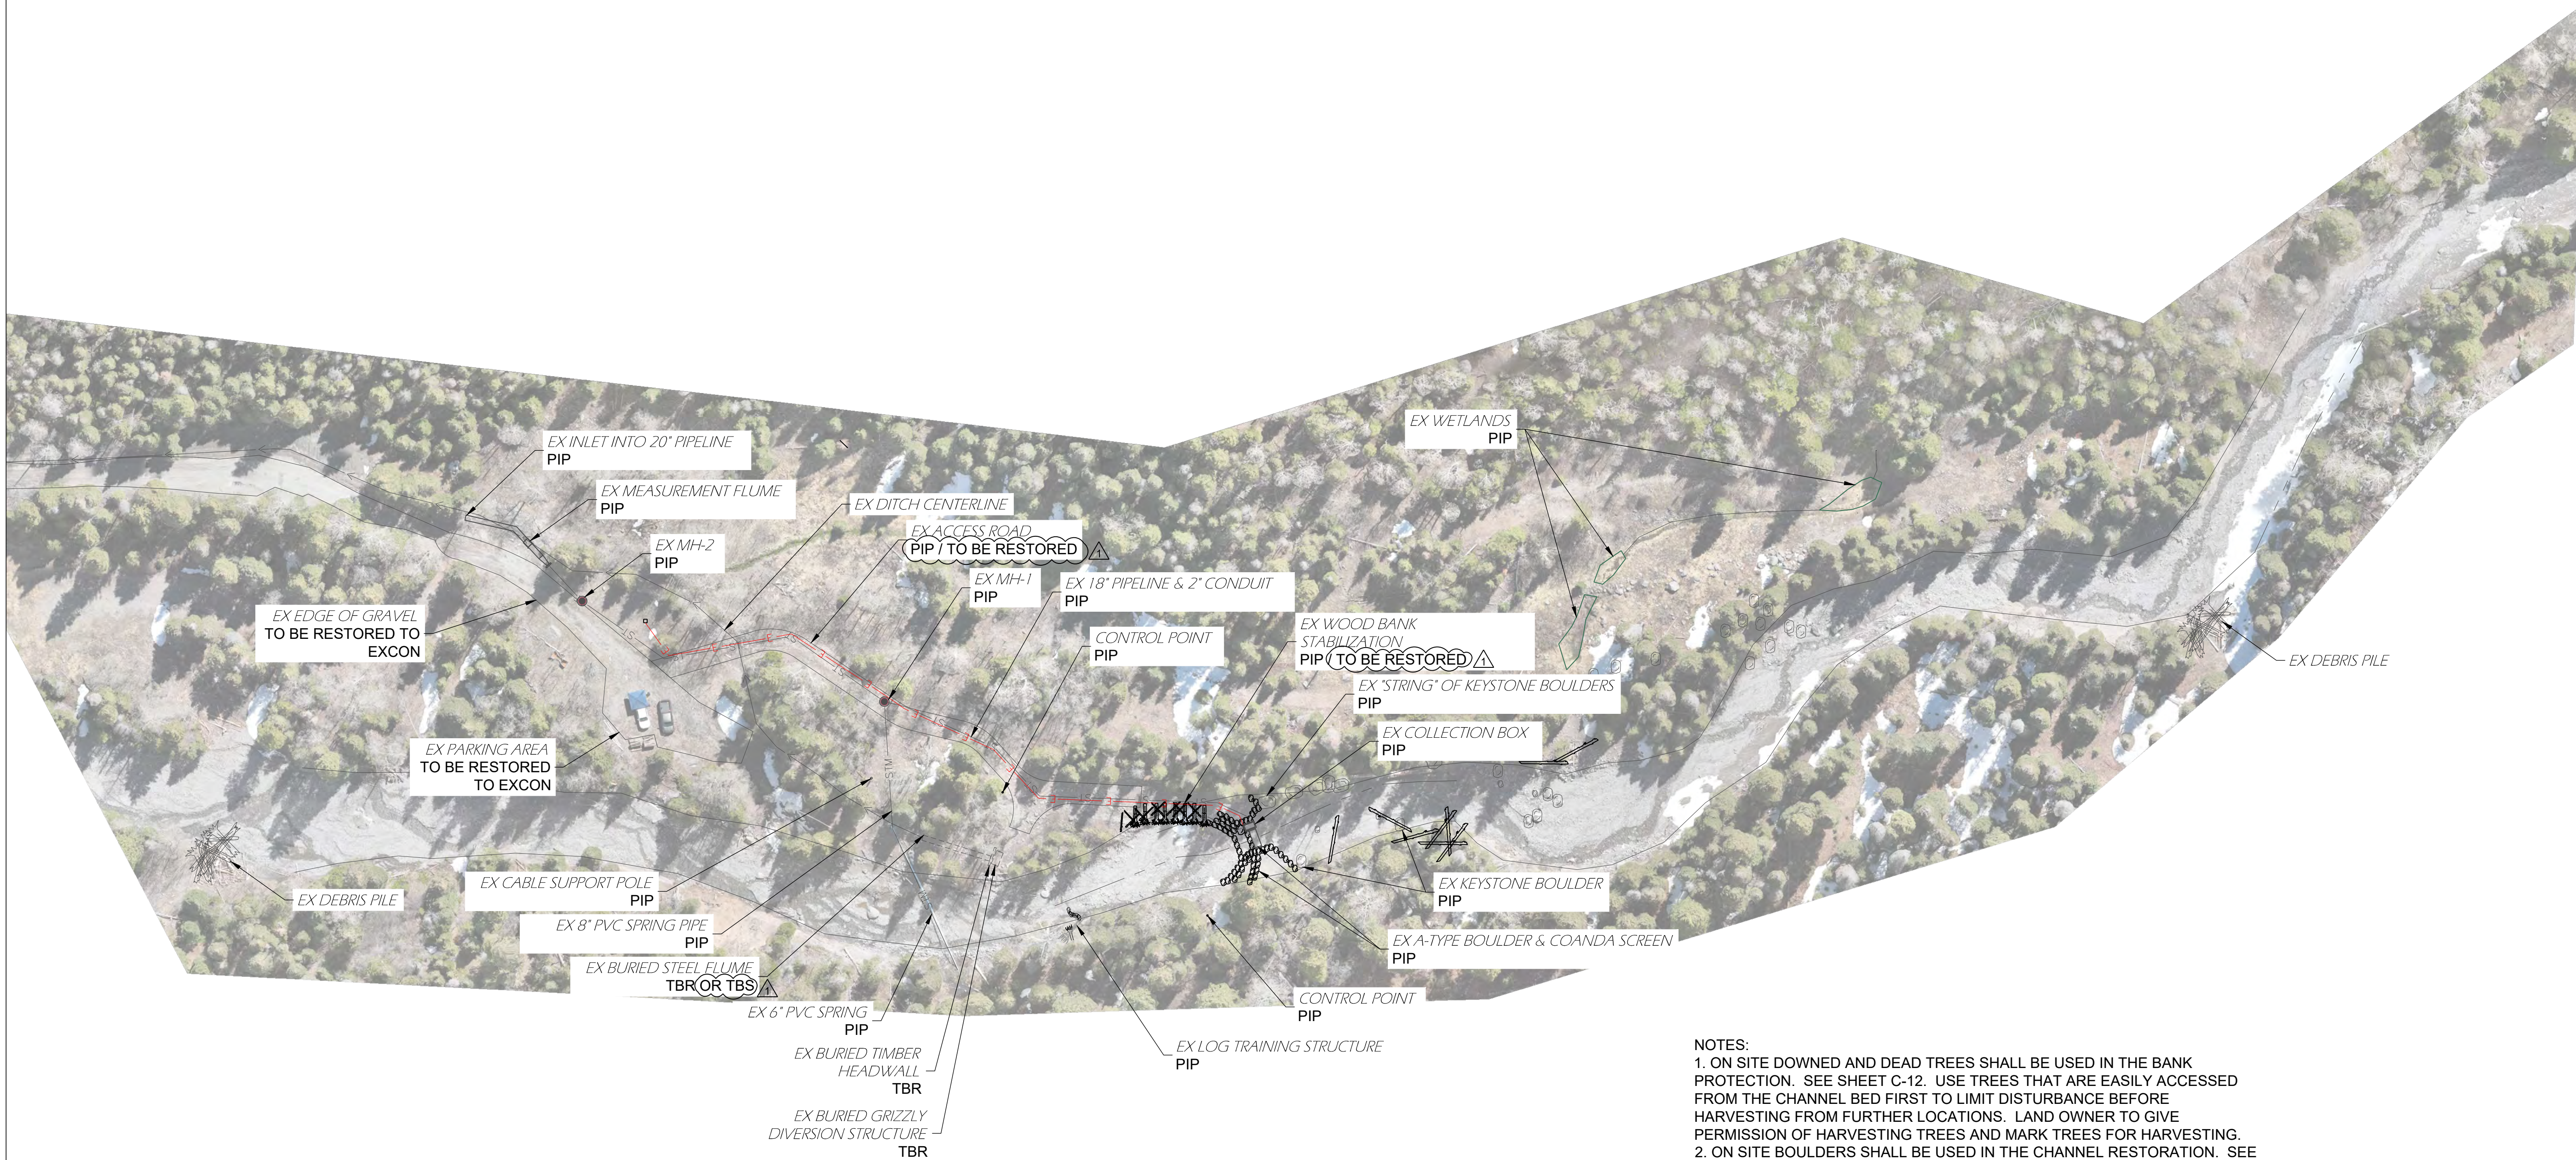
NOTES:  
1. ON SITE DOWNED AND DEAD TREES SHALL BE USED IN THE BANK PROTECTION. SEE SHEET C-12. USE TREES THAT ARE EASILY ACCESSED FROM THE CHANNEL BED FIRST TO LIMIT DISTURBANCE BEFORE HARVESTING FROM FURTHER LOCATIONS. LAND OWNER TO GIVE PERMISSION OF HARVESTING TREES AND MARK TREES FOR HARVESTING.  
2. ON SITE BOULDERS SHALL BE USED IN THE CHANNEL RESTORATION. SEE SHEET C-2. USE BOULDERS THAT ARE EASILY ACCESSED FROM THE CHANNEL BED FIRST TO LIMIT DISTURBANCE BEFORE HARVESTING FROM FURTHER LOCATIONS. LAND OWNER TO GIVE PERMISSION OF HARVESTING BOULDERS.  
3. CONTRACTOR SHALL LIMIT EXCAVATION ACTIVITIES DIRECTLY ADJACENT TO STRING OF KEYSTONE BOULDERS TO LIMIT COMPROMISING TOE RETURN STABILITY.

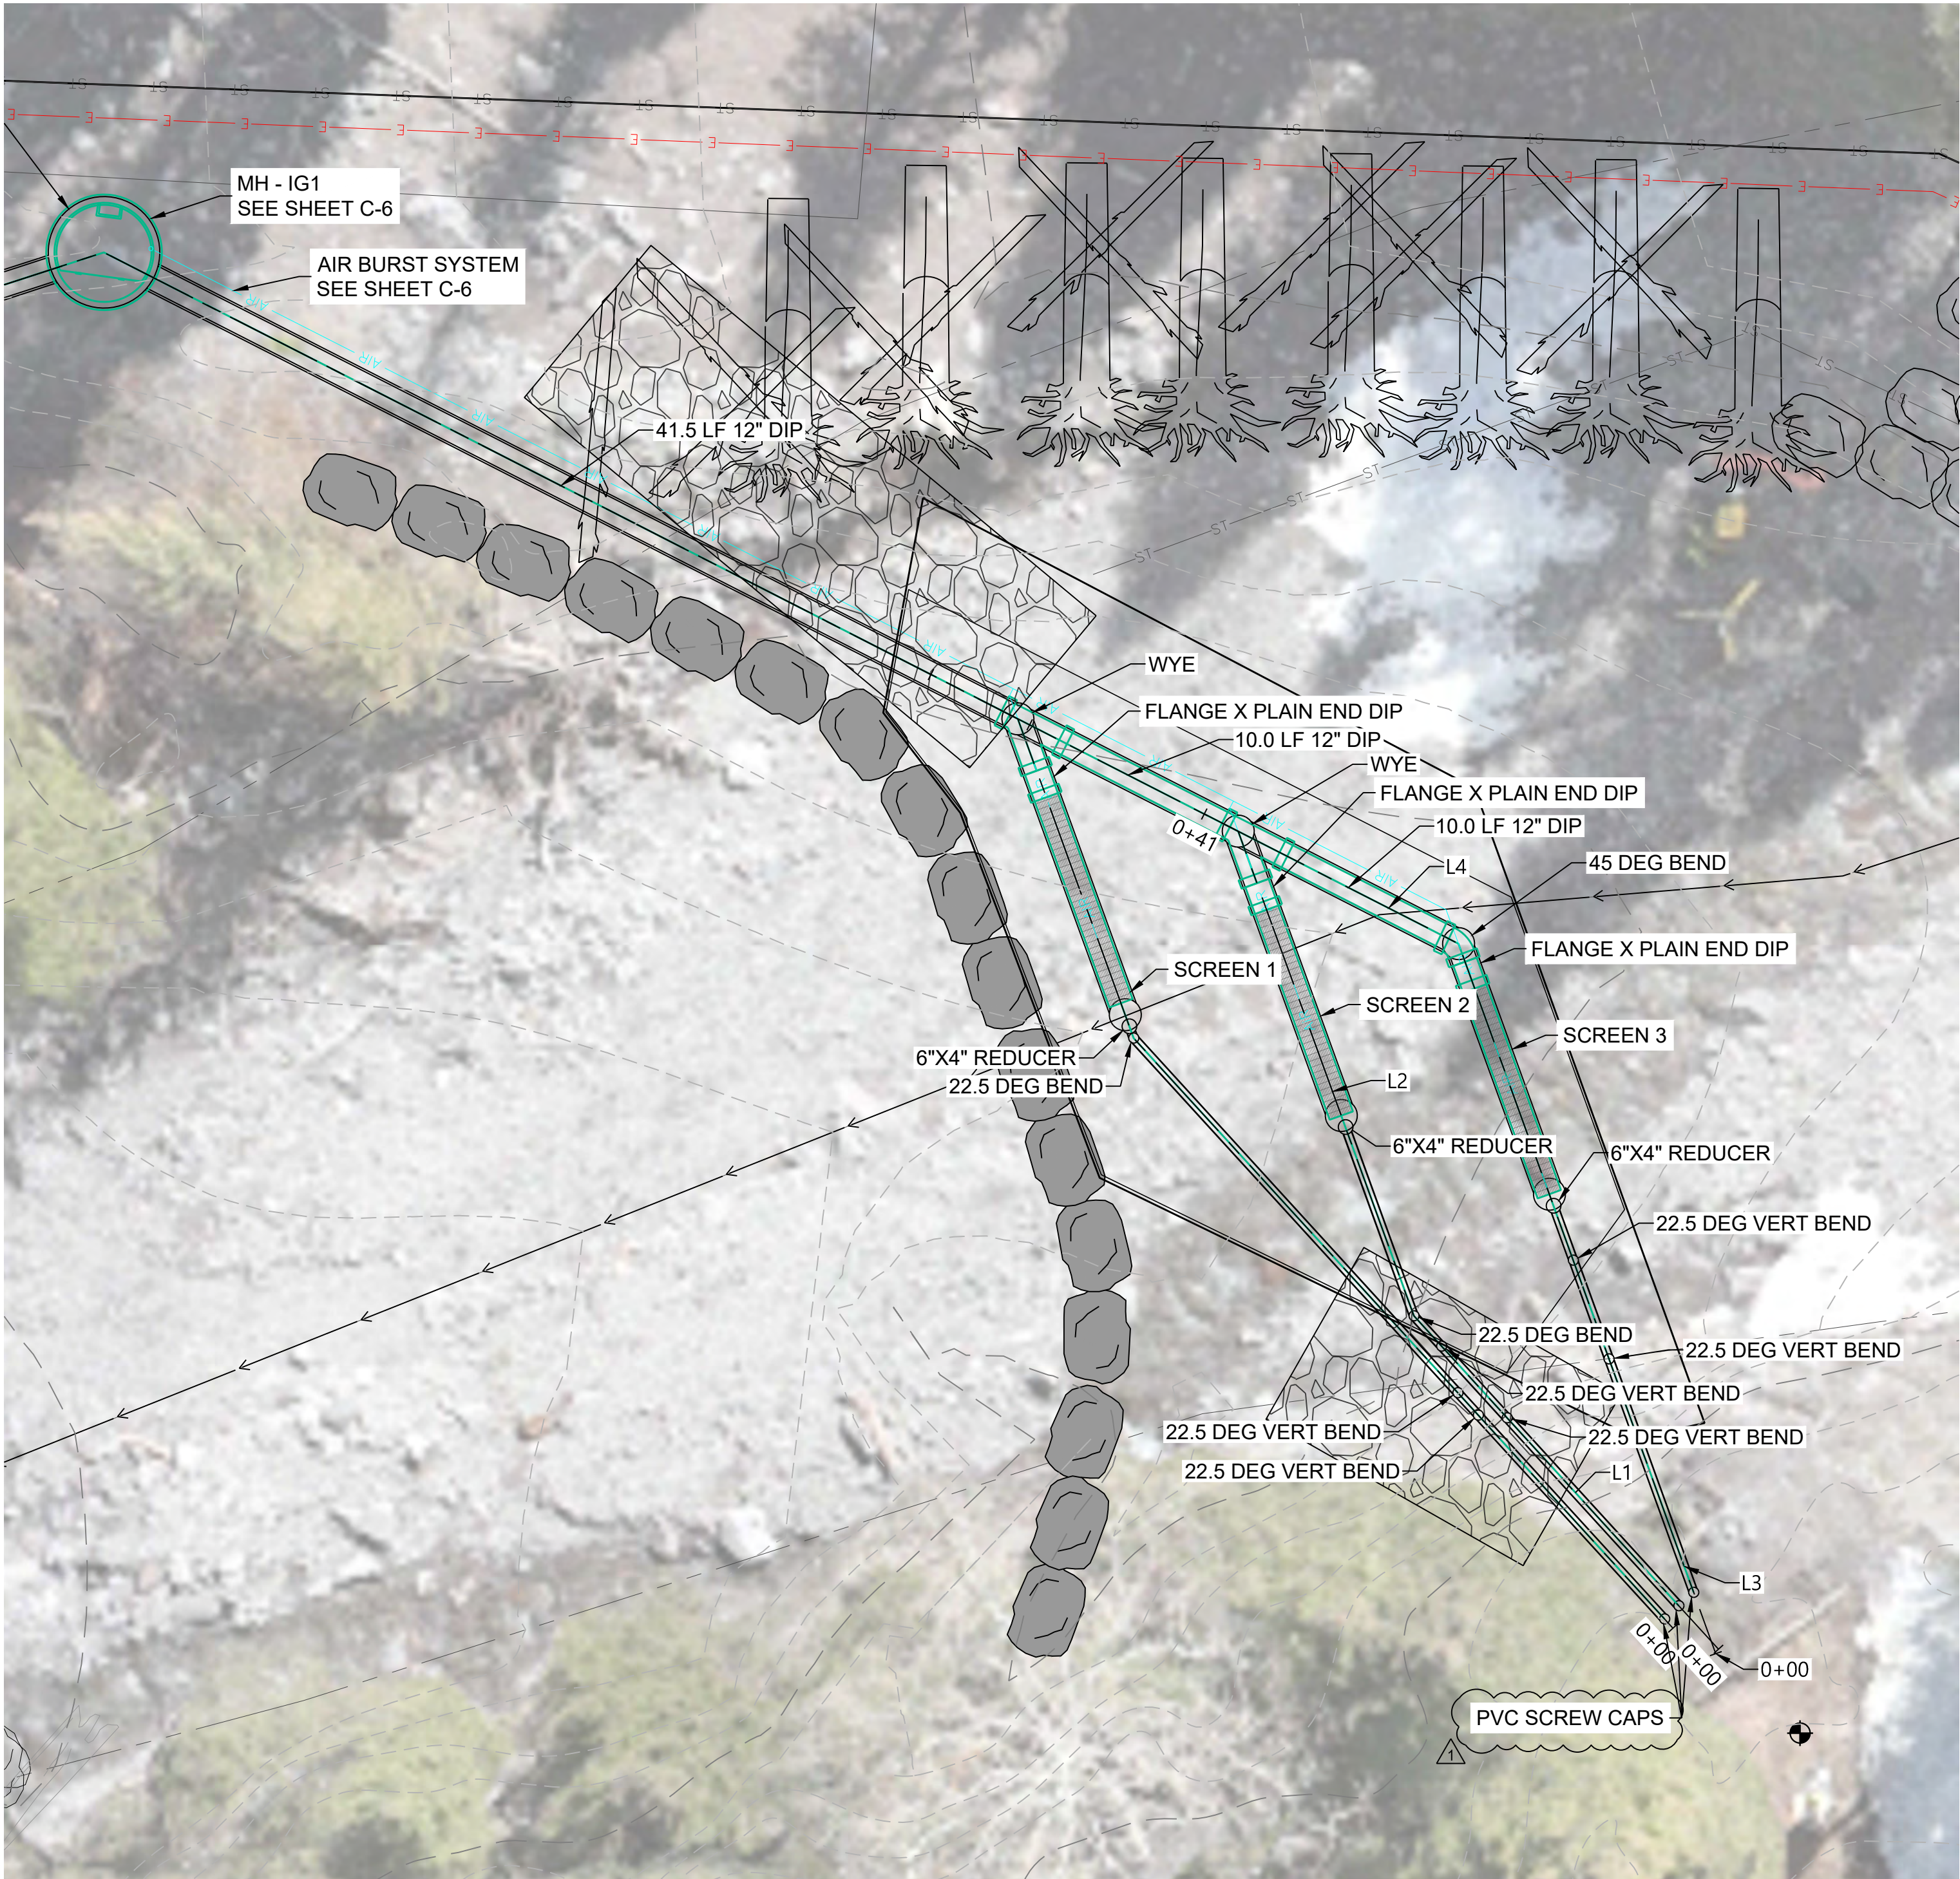
## INFILTRATION GALLERY PLA

| INFILTRATION GALLERY SCREEN 2<br>INFILTRATION GALLERY SCREEN 3 | | | | | | | | |

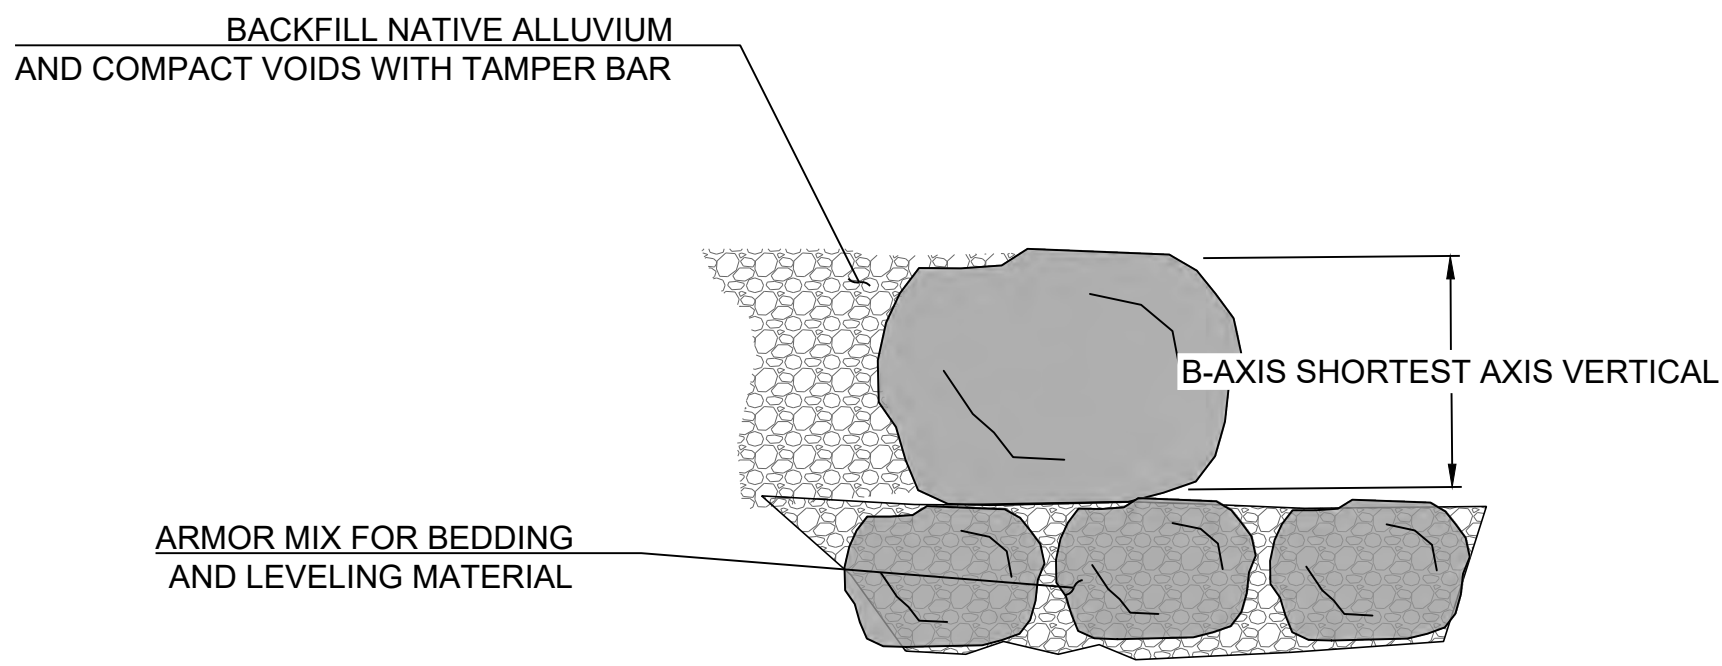
BOULDER PLACEMENT DETAIL

1. ALL ROCK MATERIALS SHALL BE HARVESTED ON SITE.
2. SORT, STOCKPILE AND SIEVING OF MATERIALS WILL BE REQUIRED TO MEET SPECIFIED BOULDER SIZES AND BEDDING MATERIAL GRADATION.
3. BOULDERS FOR STRUCTURES SHALL BE A MINIMUM OF 3' SIZE.
4. BOULDERS SHALL BE PLACED WITH THE SHORTED AXIS VERTICAL (B-AXIS).
5. BOULDER SHALL BE BACKFILLED WITH NATIVE ALLUVIUM AND WASH SIEVED IN 8" LIFTS TO FILL VOID SPACES.
6. MAXIMUM VOID SPACE BETWEEN BOULDERS IS 3" WHICH SHALL BE WASHED SIEVED WITH NATIVE ALLUVIUM.
7. ARMOR MIX SHALL BE INSTALLED AND COMPACTED IN 2' LIFTS. ALTERNATIVELY, LARGER AGGREGATE CAN BE PLACED AT THE DIRECTION OF THE ENGINEER IN SATURATED CONDITIONS.
8. BEDDING SHALL FORM A EVEN FLAT GRADE TO STACK BOULDERS.
9. SUBSEQUENT ROWS OF BOULDERS SHALL HAVE INTIMATE CONTACT WITH FOOTER BOULDERS. WASH SIEVE THE VOIDS AND COMPACT WITH TAMPER BAR.

Response: There are boulders downstream of the 6" spring line that can be harvested.

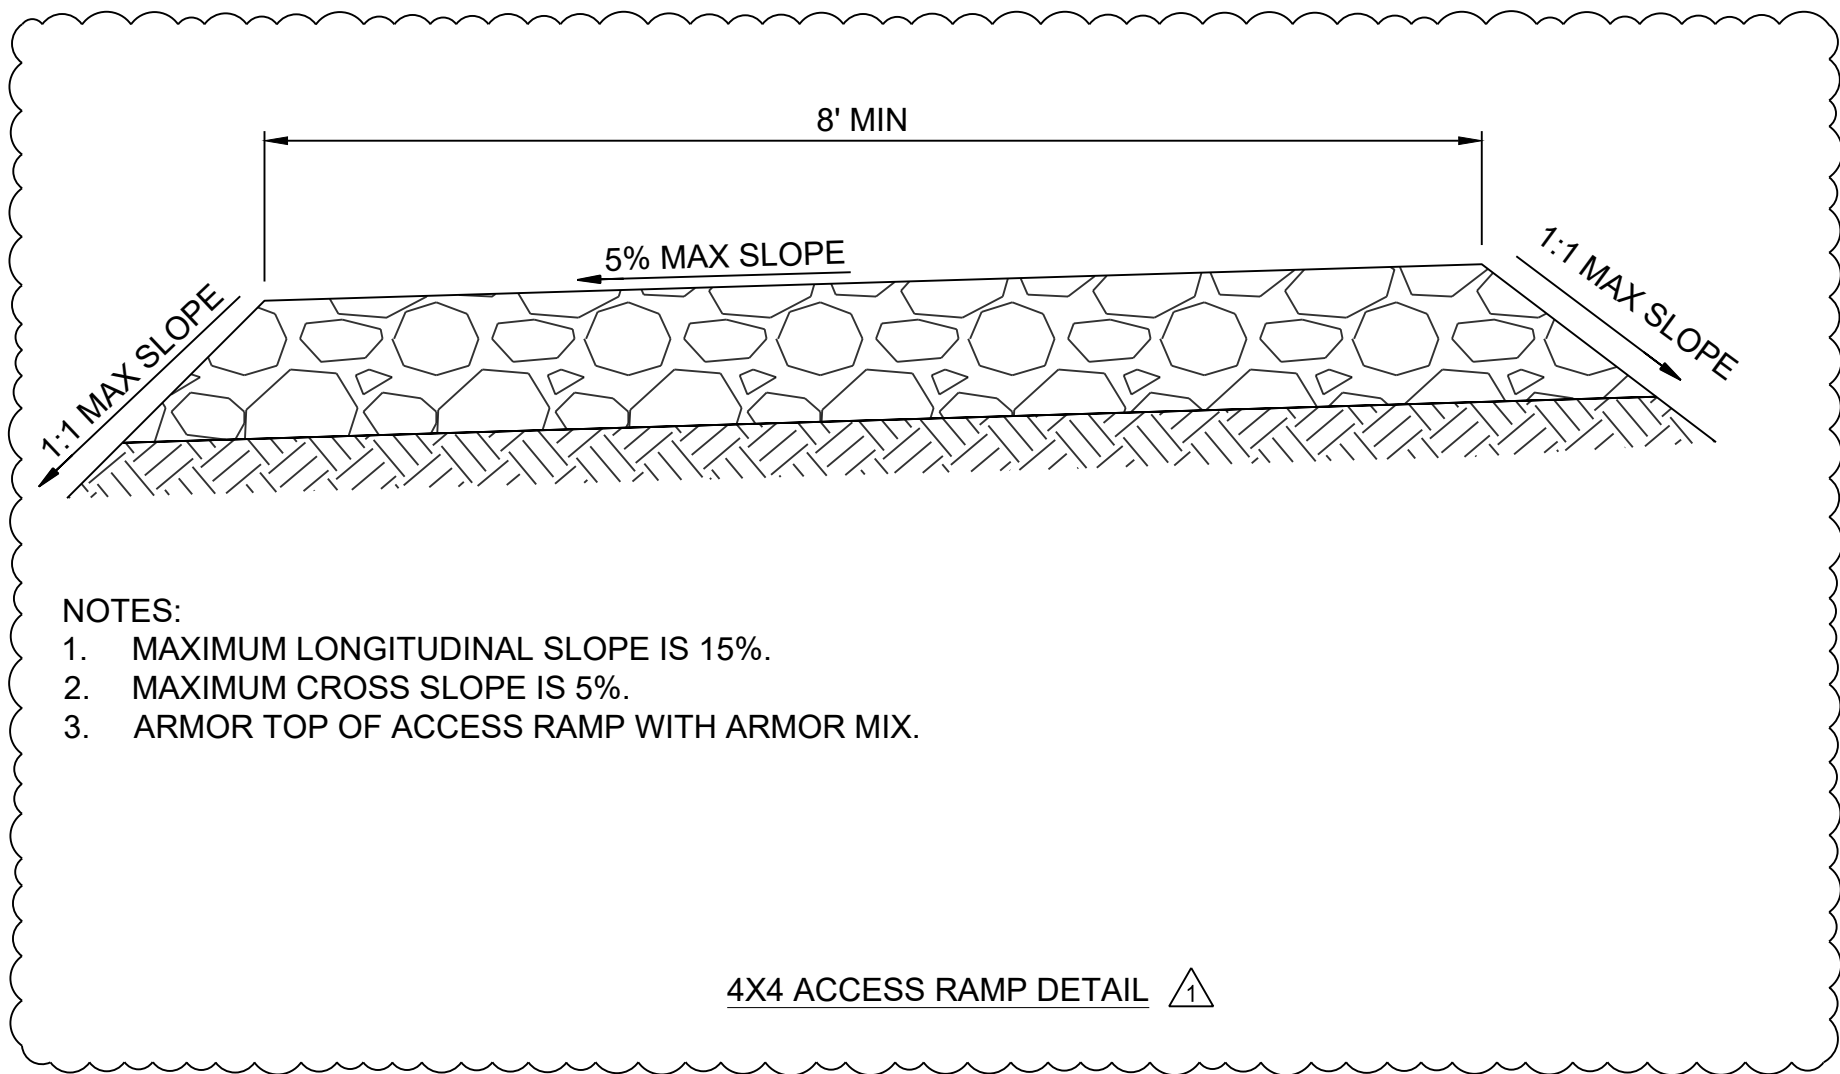
4X4 ACCESS RAMP DETAIL

- NOTES:
1. MAXIMUM LONGITUDINAL SLOPE IS 15%.
  2. MAXIMUM CROSS SLOPE IS 5%.
  3. ARMOR TOP OF ACCESS RAMP WITH ARMOR MIX.

Response: The plans attached to this addendum include a 4x4 access across to the west bank for access to the water jet the infiltration gallery. There are dead and downed trees on the west bank that can be salvaged for the bank stabilization.

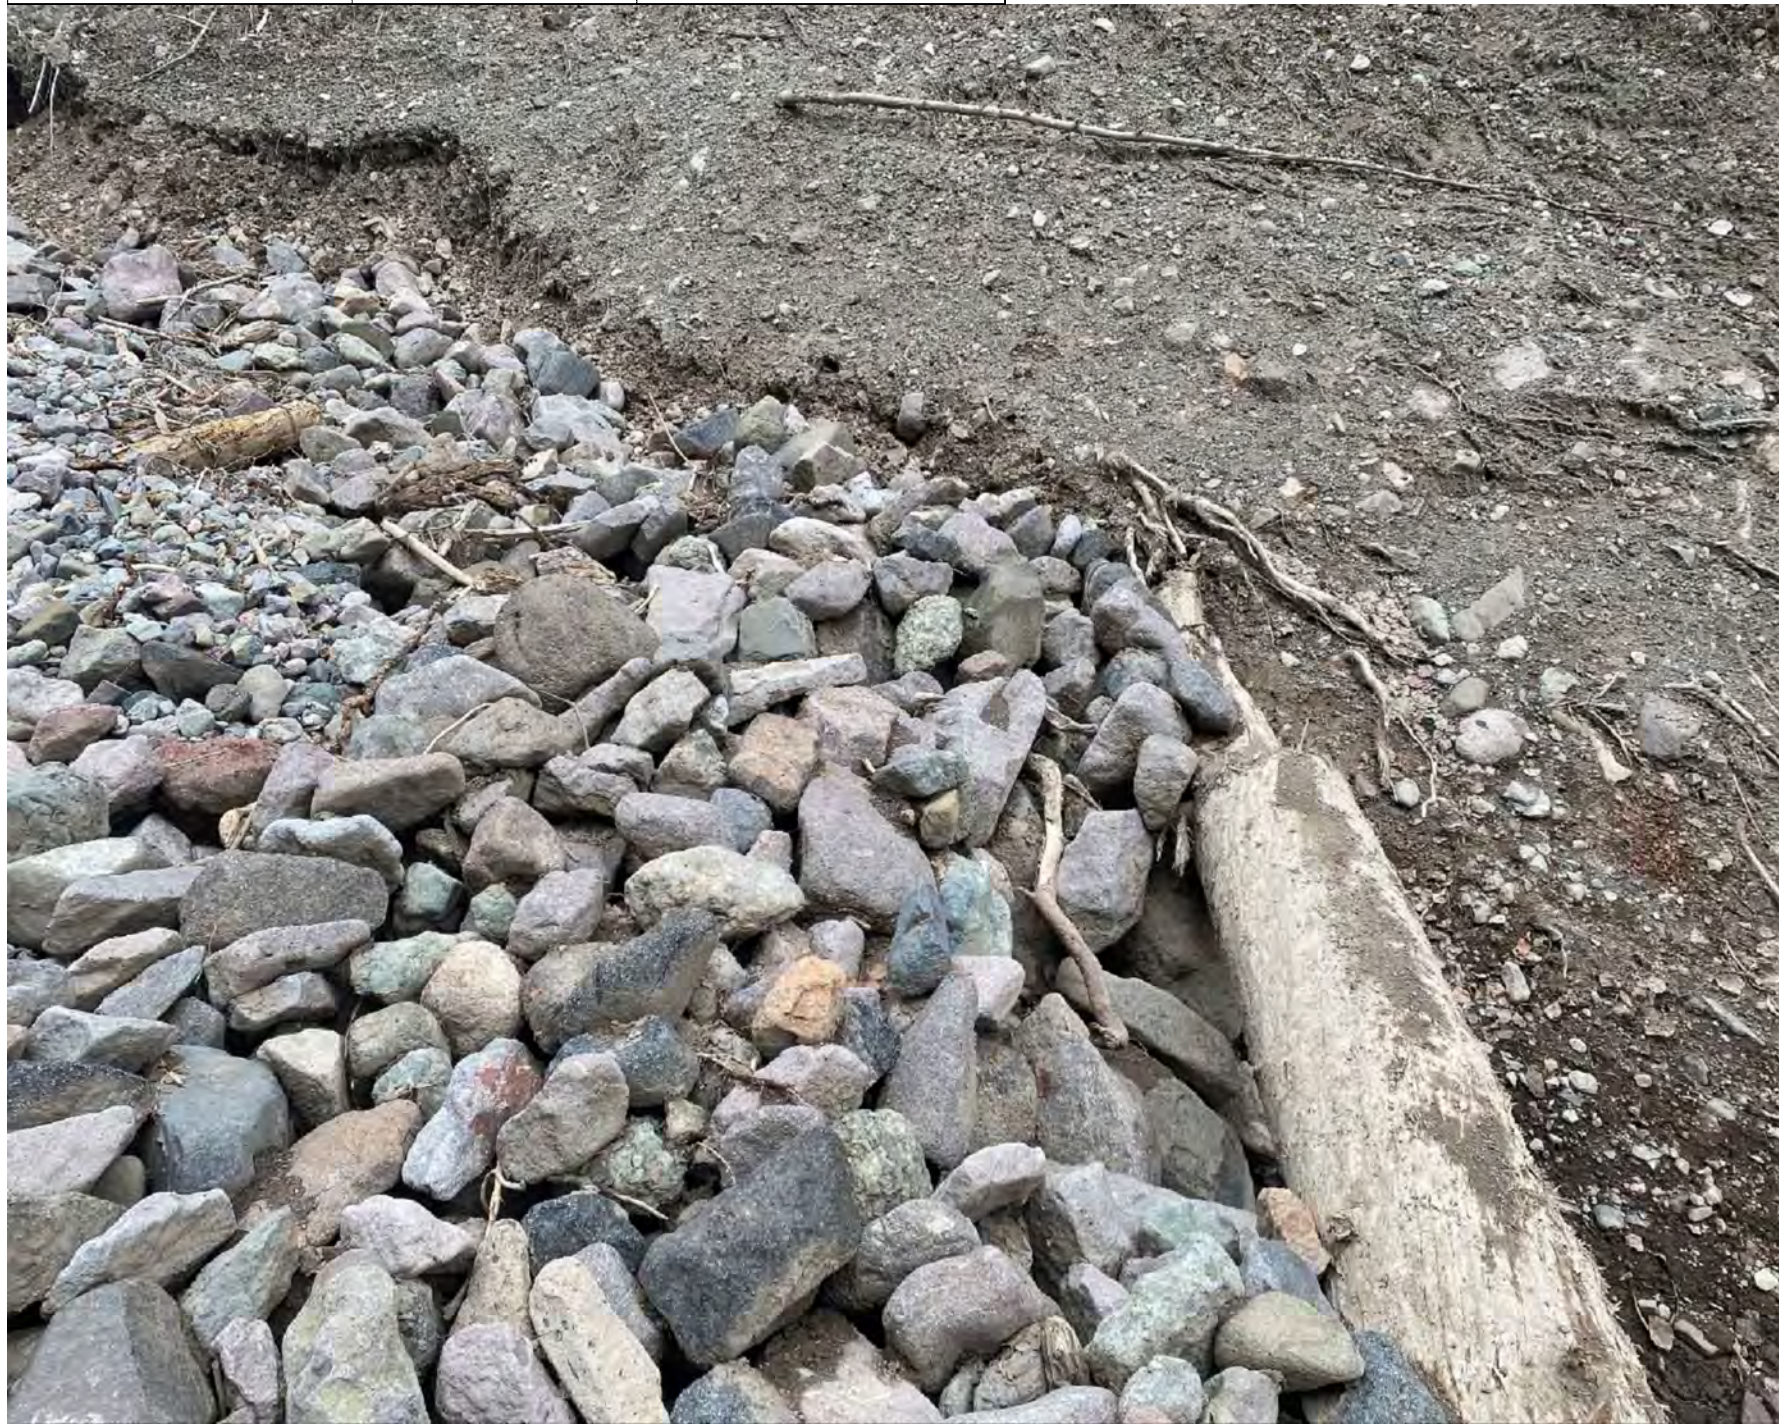
| ARMORED MIX | | |
|---|---|---|
| APPROXIMATE PROPORTIONS (EXCAVATOR BUCKETS) | MATERIAL TYPE | MATERIAL DESCRIPTION |
| 6 | BOULDERS | >1' TO 2' BOULDERS |
| 3 | COBBLES | 3" TO 1' ROCK |
| 2 | GRAVEL | <3" GRAVEL |

FIGURE 1: EXAMPLE IMAGE OF ARMORED MIX

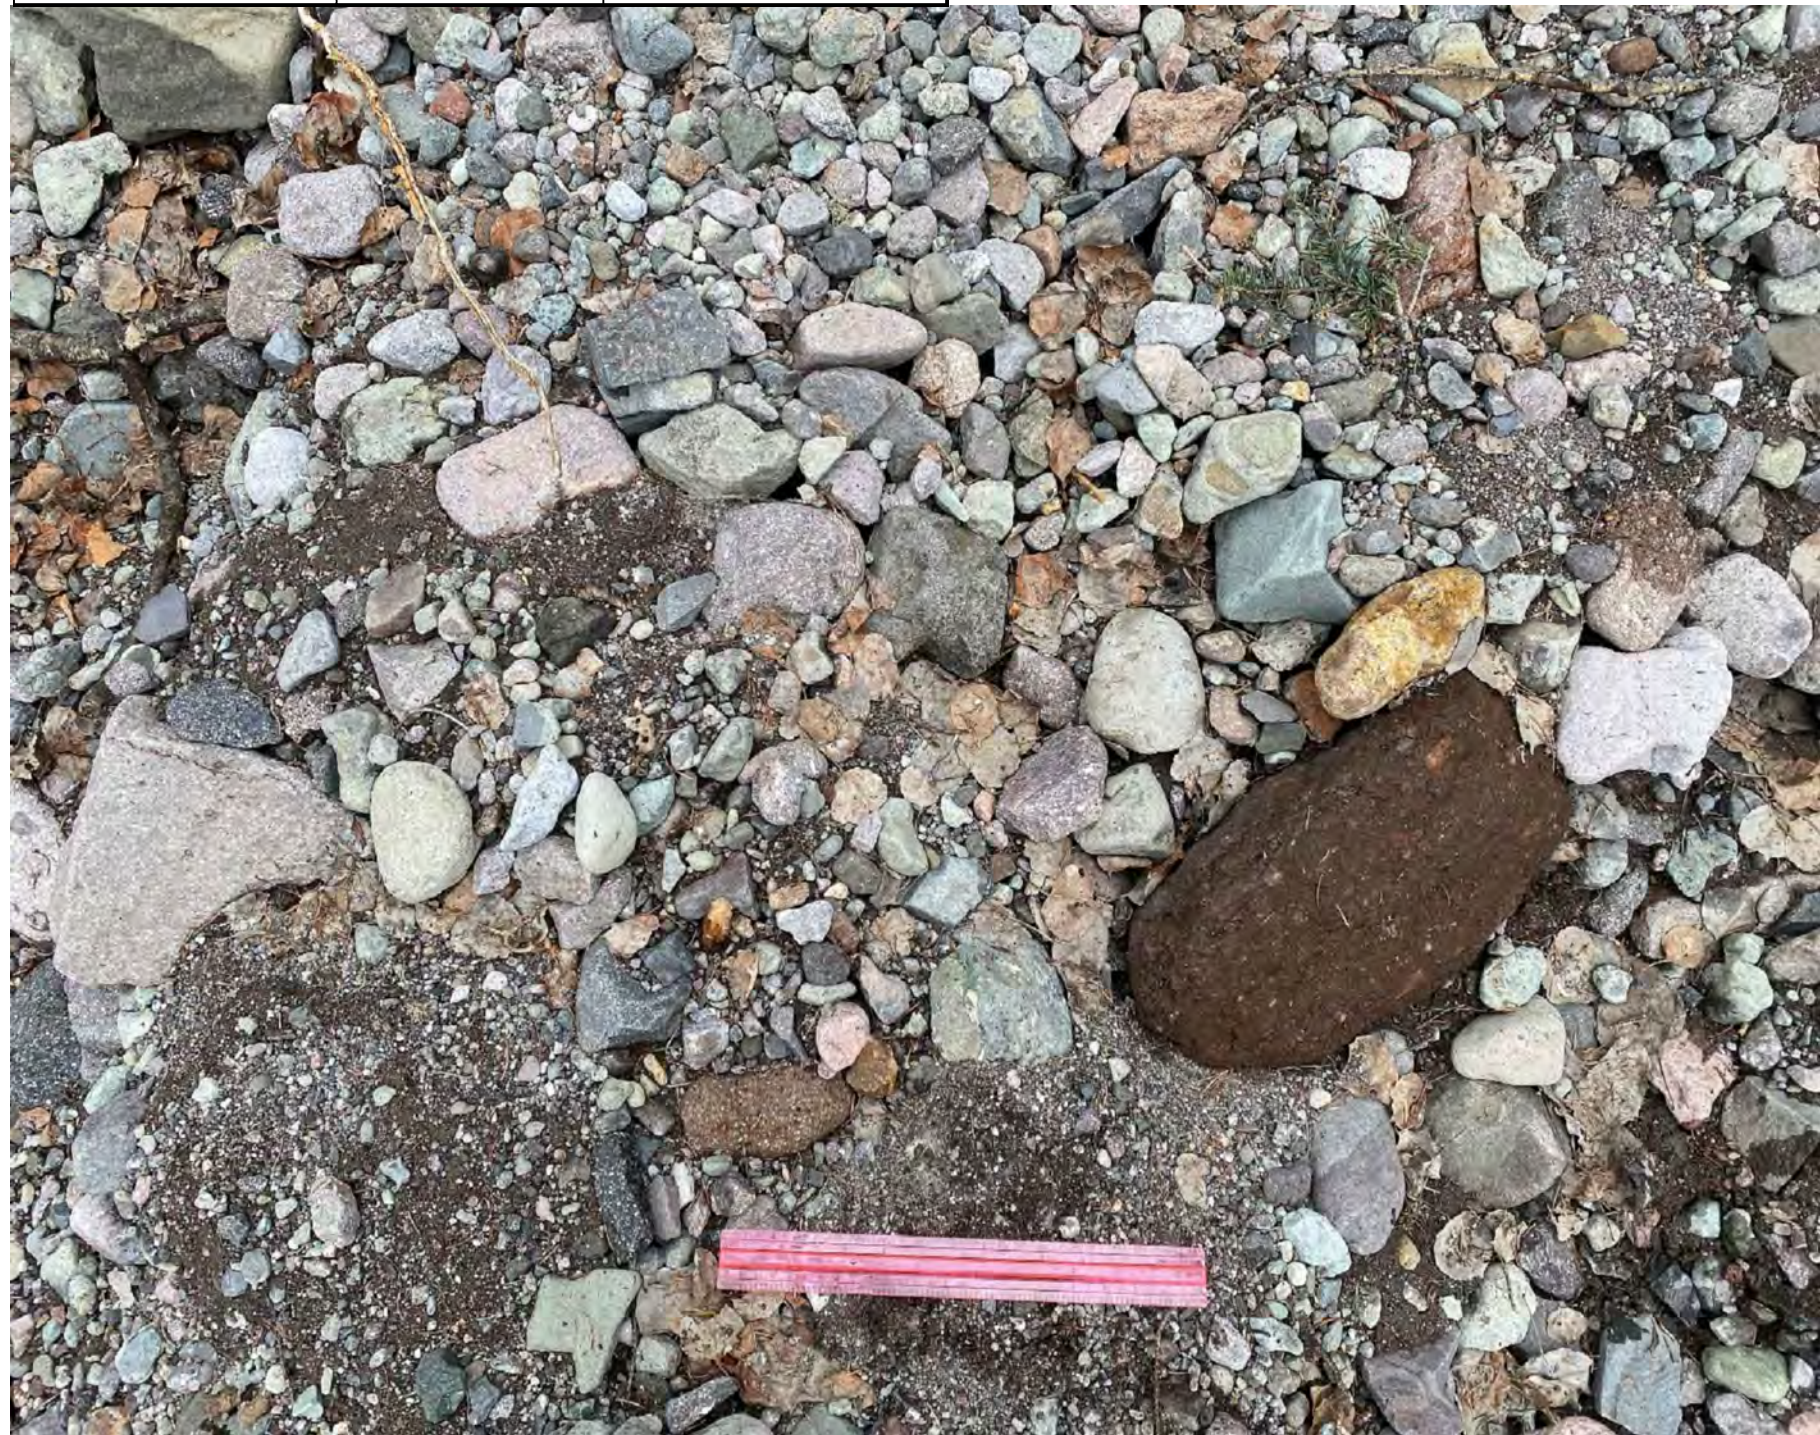
| NATIVE ALLUVIUM MIX | | |
|---|---|---|
| APPROXIMATE PROPORTIONS (EXCAVATOR BUCKETS) | MATERIAL TYPE | MATERIAL DESCRIPTION |
| 1 | BOULDERS | ~1' |
| 3 | COBBLES | 3" TO 1' ROCK |
| 3 | GRAVEL | <3" GRAVEL |

FIGURE 2: EXAMPLE IMAGE OF NATIVE ALLUVIUM MIX

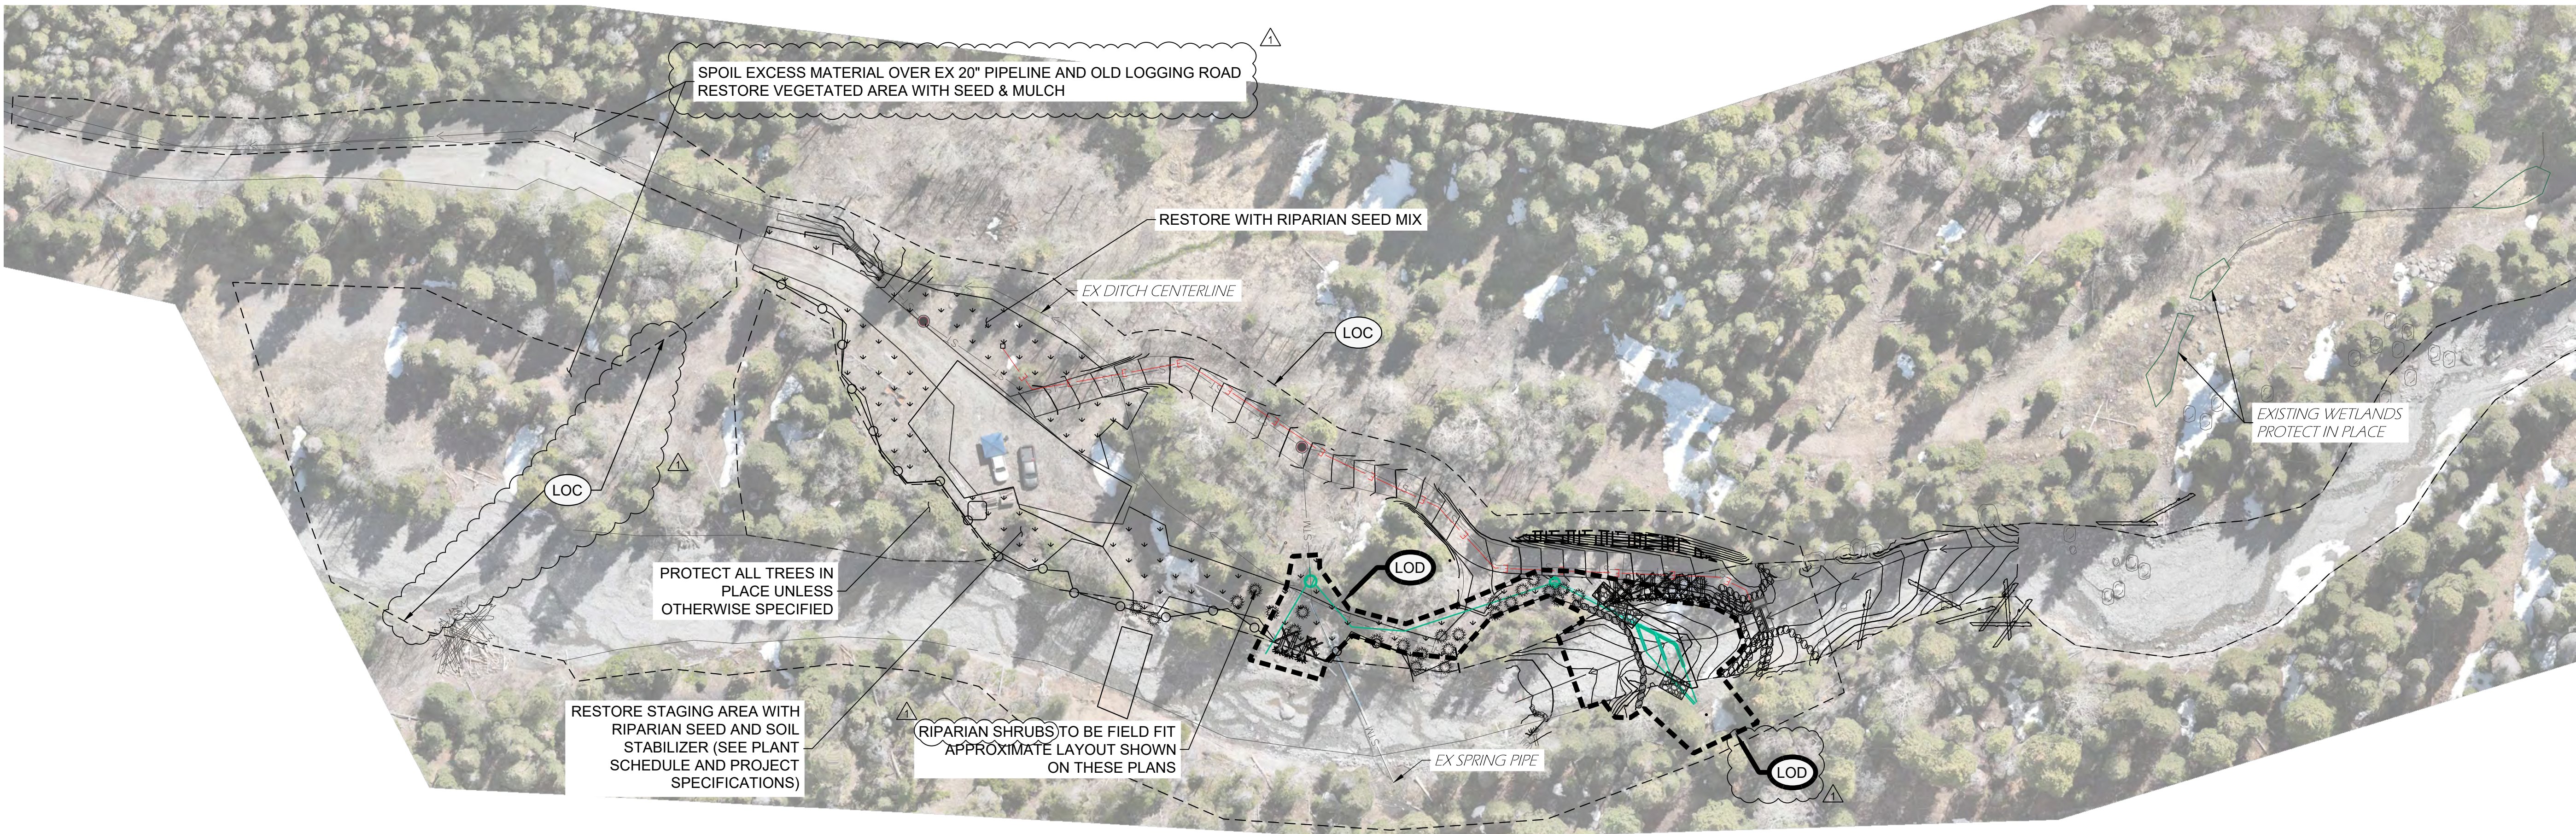
| DRAWING NUMBER: | | ER-2<br>SHEET 13 | |

1. ALL MATERIALS SHALL BE FREE OF WEEDS AND NATIVE STRANDS.
2. ALL SEEDED AREAS SHALL BE DRILL SEED AND COVERED WITH SOIL STABILIZER.
3. SOIL STABILIZER SHALL BE MULCH TACKIFIER APPROVED BY THE ENGINEER.
4. CONTAINER PLANTS SHALL BE FIELD PLACED AND PLANTED IN DESIGNATED AREAS OUTSIDE OF THE PERMANENT MAINTENANCE ACCESS ROAD AND CHANNEL ACCESS LOCATIONS.
5. CONTAINER PLANTS SHALL BE PLANTED IN CLUSTERS OF 3-5 AND SPACED 3 FT O.C.
6. FINAL PLANTS ARE BASED ON AVAILABILITY TO BE APPROVED BY ENGINEER.
7. LIVE STAKES SHALL BE GEYER WILLOW OR RED OSIER DOG WOOD AND SOURCED OFFSITE.
